## RÜZGEM (METUWIND) Center For Wind Energy Research

| <b>Test Name</b> | Ferrini Zipline 105 & Zipline Neo Wind Test |
| <b>Client</b> | SKS Monostar Panjur San. Tic. A.Ş. |
| <b>Document Number</b> | RUZGEM-2022-ER041 |

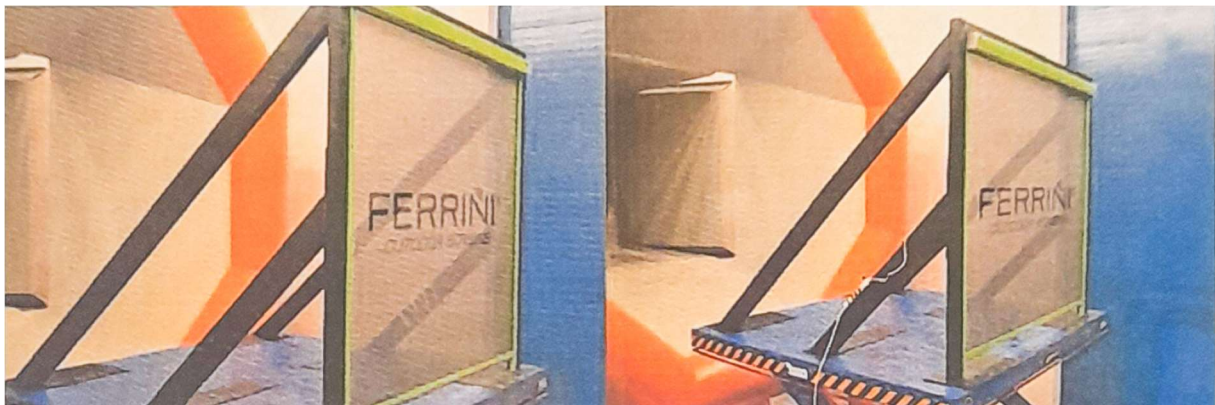
**Figure 1:** View of Zipline 105 (left) and Zipline Neo (right) zip screens on the test section .

- **First Test:** The **Ferrini Zipline 105** model, with dimensions of **2450 mm x 2450 mm**, was tested .
- **Second Test:** The **Ferrini Zipline Neo** model of the same dimensions was tested in the METU RÜZGEM Large Wind Tunnel Open Jet test section .

The view of the zip screens in the Open Jet test section before the test started is shown in Figure 1.

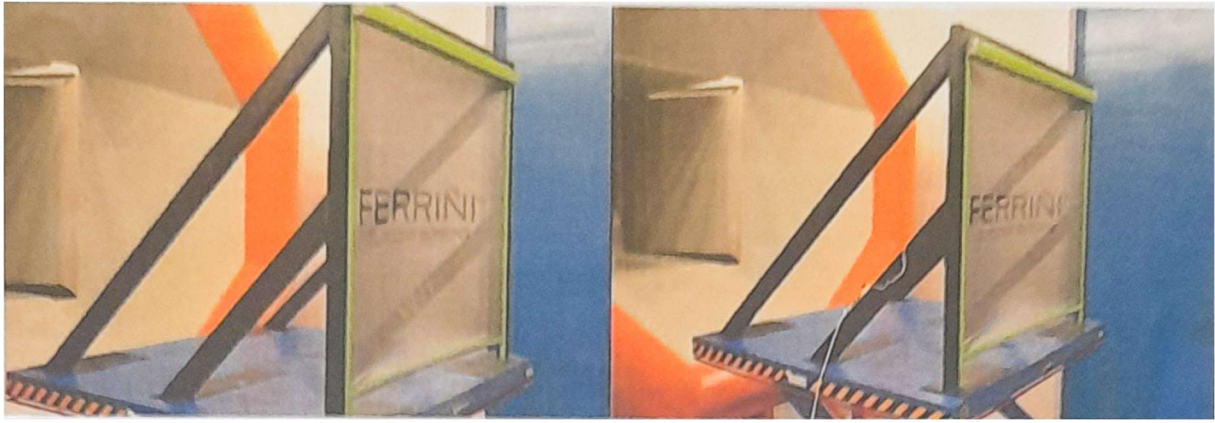
**Figure 3:** Zipline 105 (left) and Zipline Neo(right) under wind load .

Graphs belonging to the wind speeds the test objects were subjected to are shown in Figure 2 . The view of the zip screens under wind load is shown in Figure 3 .

- **Structural Integrity:** Upon post-test inspection, no structural deformation, tearing, breaking, or snapping was observed in either zip screen model.
- **Mechanism Functionality:** No issues were observed in the opening and closing mechanisms of either model.
- **Disassembly:** Following the completion of the tests, the test objects were disassembled by Ferrini personnel under the supervision of RÜZGEM staff .
